# **Rockfall Hazard Condition at Makena State Park Maui, Hawaii**

Earth Tech, Inc.  
841 Bishop Street, Suite 500  
Honolulu, Hawaii 96813-3920

October 30, 2006

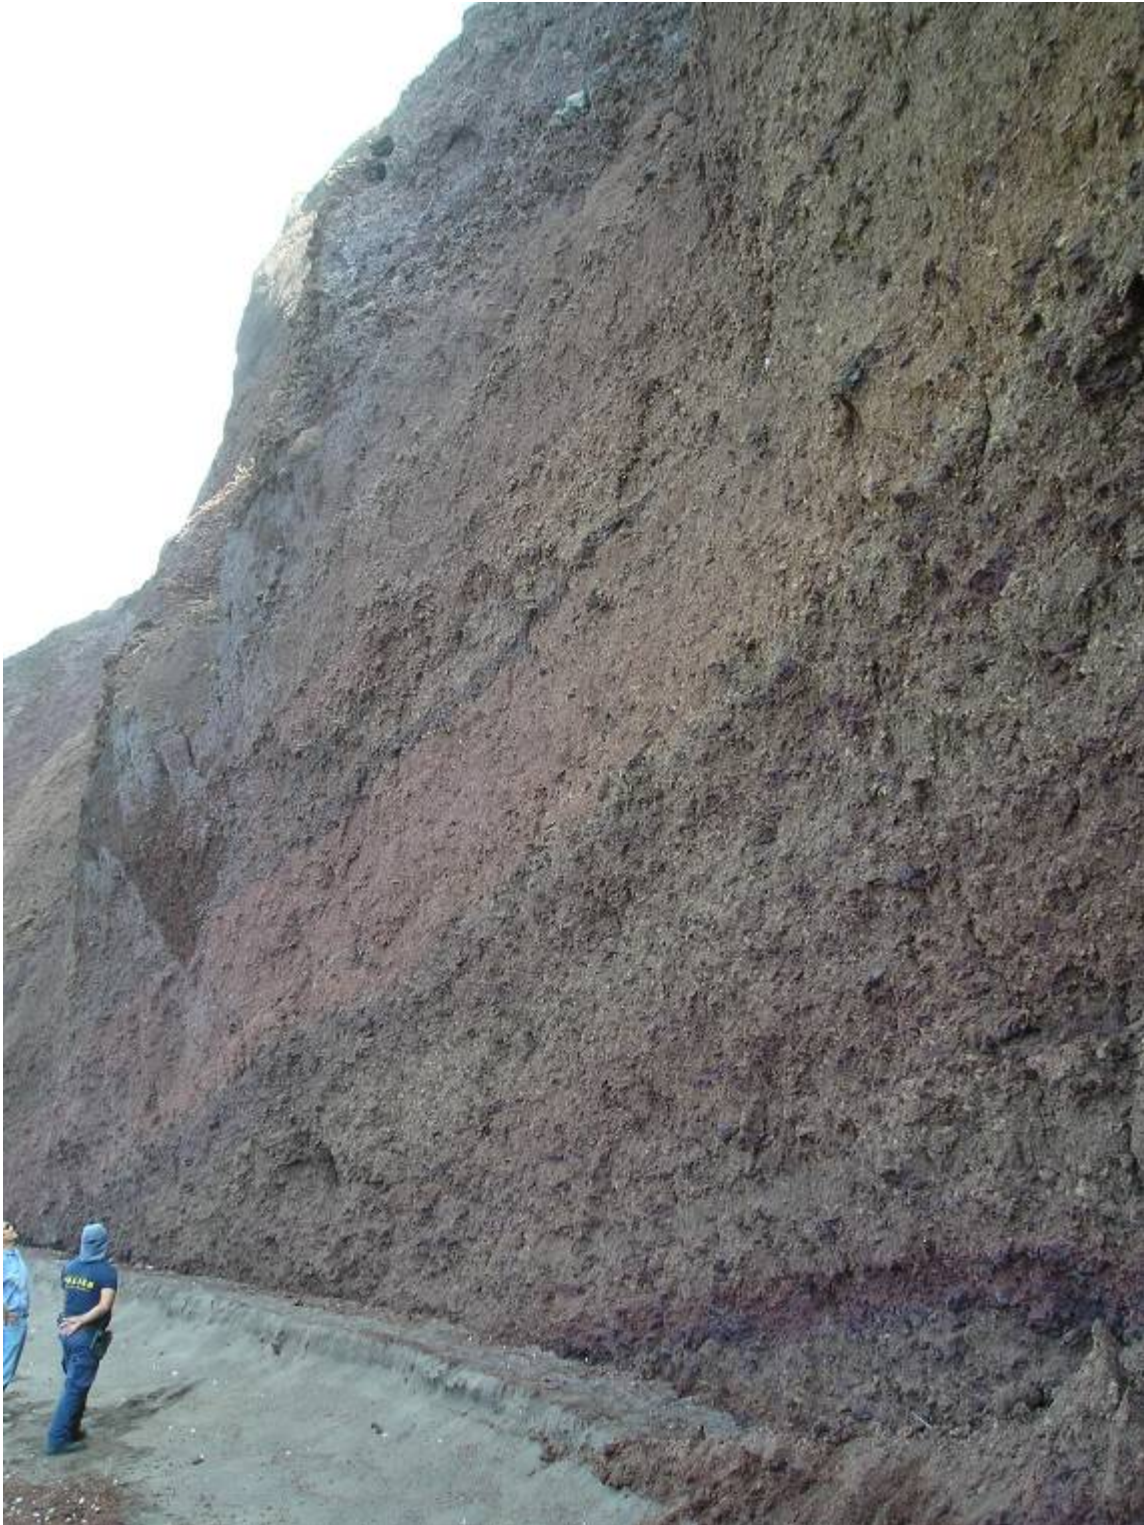
- 4) Falling of egg-sized (or larger) cinders onto the beach will be pervasive (Photo 17) as most cinder layers at Black Sand Beach are loose with poor cementation (Photo 16).

Photo 17. As most cinder layers at Black Sand Beach are very loose with poor cementation, falling of egg-sized (or larger) cinders onto the beach will be a constant problem. Black Sand Beach, Makena State Park.

For Black Sand Beach, the first three types of rockfall hazards can be similarly addressed by scaling and optional demolition and bolting. The fourth type of rockfall hazards, namely the pervasive and constant falling of egg-sized cinders from loose cinder layers will be difficult to secure. The normal method of shotcreting or pinning a mesh system (with a fine layer and deep anchors) for the whole slope is not recommended due to aesthetic and cost considerations.

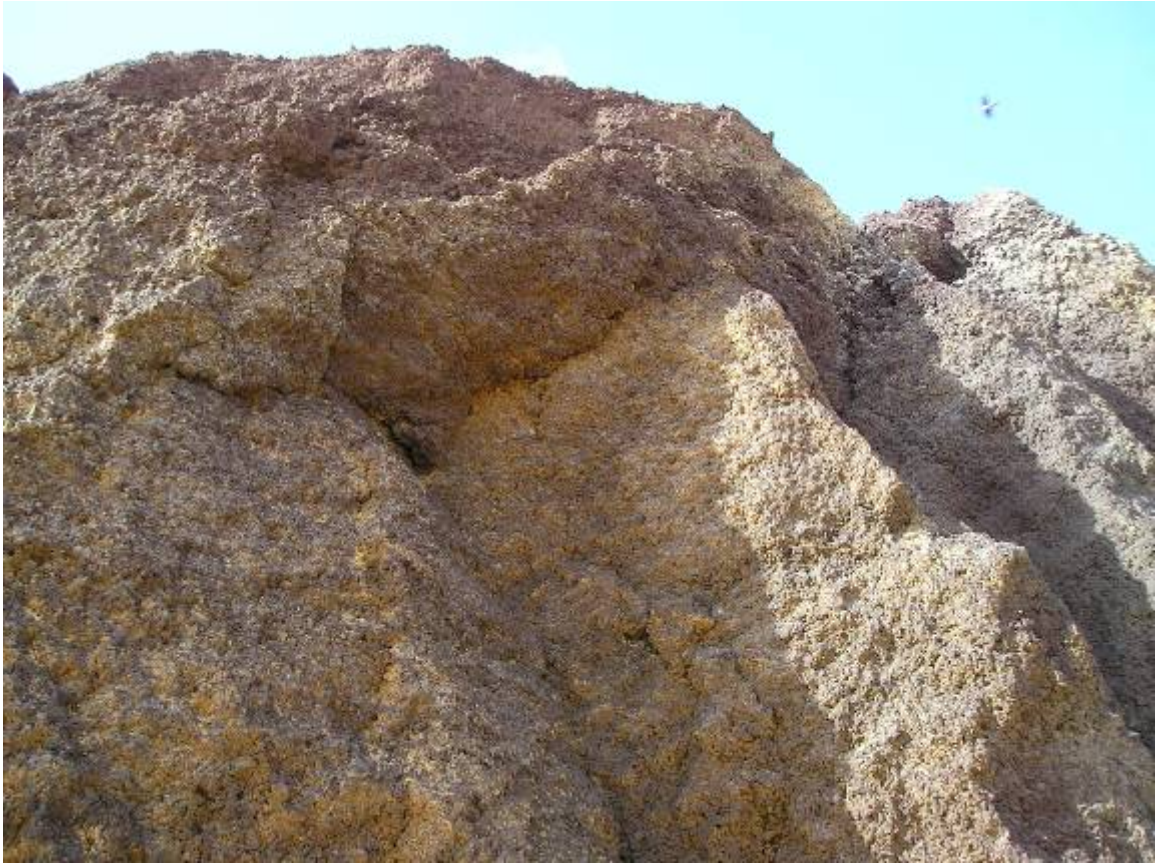
Rockfall hazards at Big Beach include a few loose boulders, the weak veneer layer (Photo 9), and the fractured and overhang hard cinder layers (Photo 8, Photo 18 and Photo 20). The rate to produce new rockfalls in the hard cinder layers at Big Beach is much slower than that in the loose cinder layers at Black Sand Beach.

Photo 18. Very hard cinder layers with strong welding at Big Beach, Makena State Park.

For Big Beach, scaling and optional limited demolition and bolting are recommended. Scaling will remove the loose boulders and hazardous loose debris (Photo 9) and well fractured rocks (Photo 8). Demolition may be used to remove hazardous overhangs if they cannot be removed by scaling (Photo 18). Rock bolting may be used to stabilize large pieces of the hard cinder layers (Photo 20) if their rates of settlement increase with potential for toppling failures. During construction, only small portions of Big Beach need to be closed. The cost of scaling with optional limited demolition and bolting is approximately \$100,000.

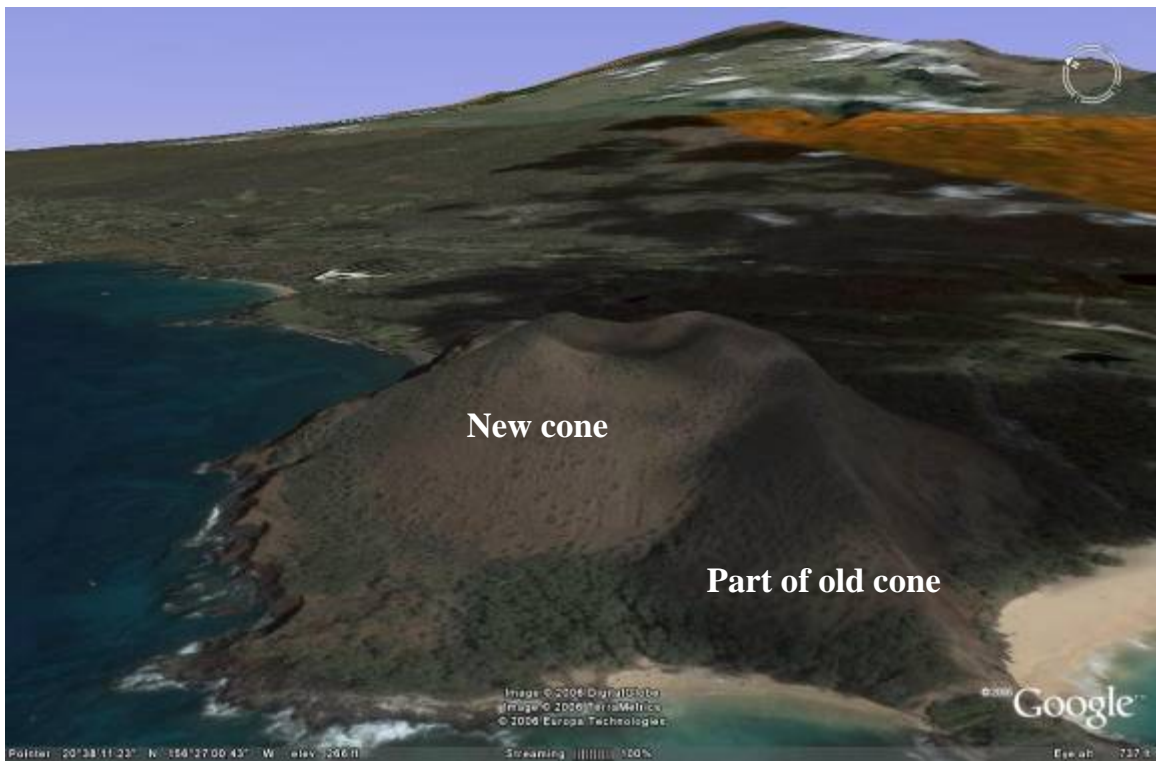
Most of the cinder layers at Big Beach are quite different from those at Black Sand Beach. Compared to the steep dipping angles (close to 40 degrees, the angle of repose) of cinder layers at Black Sand Beach (Photo 3, Photo 4, Photo 5, and Photo 7), the dipping angles of most cinder layers at Big Beach are much gentler (Photo 2, Photo 8, and Photo 11) with only a thin and steep-dipping surface veneer layer (Photo 2 and Photo 9). In addition, the gentle-dipping cinder layers at Big Beach are very hard with strong welding between cinders (Photo 18). The gentle-dipping cinder layers at Big Beach probably are part of an old cinder cone formed directly by the deposition of hot cinders (good welding and no sliding after deposition) while the steep-dipping loose cinder layers at Black Sand Beach are part of a new cone formed by the deposition of relatively cold cinders and further sliding after deposition to take the angle of repose (Photo 19).

Photo 19. The new and old cones at Makena State Park.

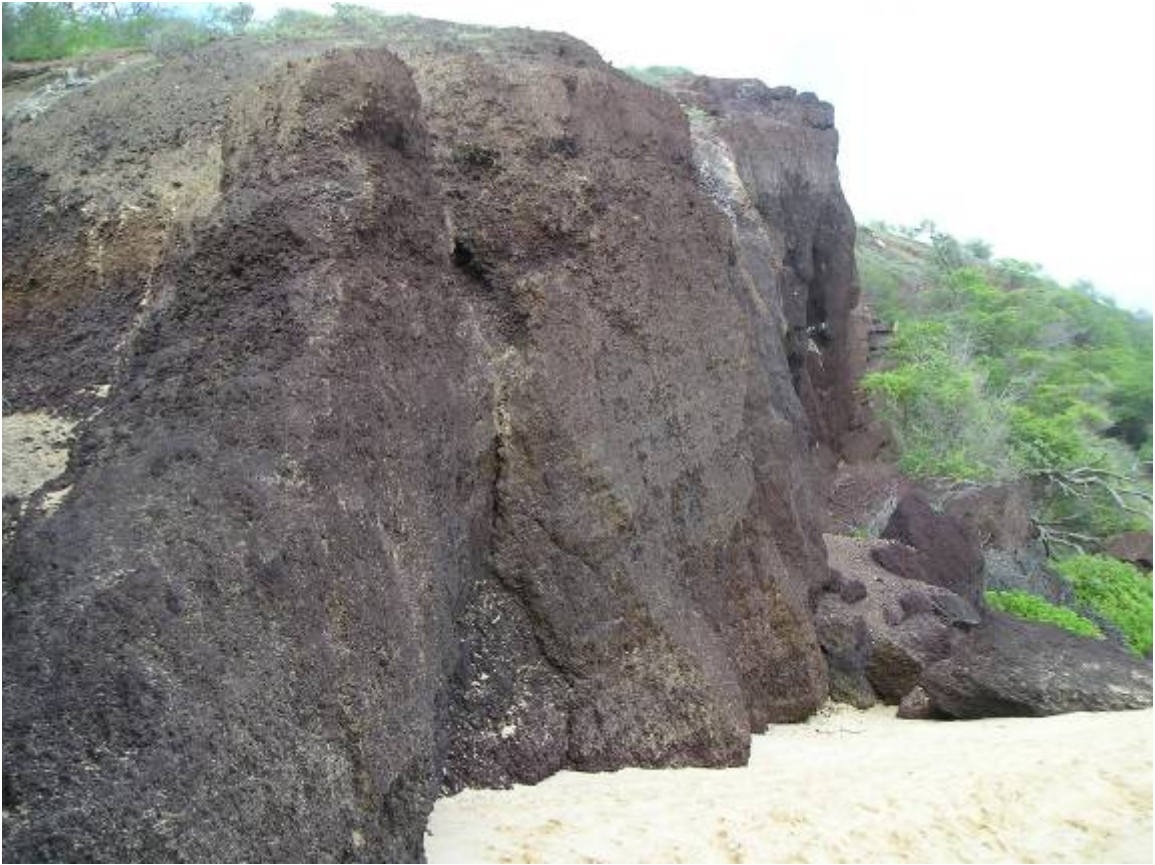
Photo 20. A large fracture in the hard cinder layers at Big Beach, Makena State Park.
